Deficiency Photo of the Year - 2021

Ship name:	OCEANA
IMO Number:	9634684
Flag:	Antigua and Barbuda
Call sign/MMSI	V2GK4/305969000
Ship type:	Container ship
Date keel laid:	07.04.2012
Gross tonnage:	17,769
Recognized organization:	DNV AS
ISM Company:	Leonhardt & Blumberg Shipmanagement
	GmbH & Co KG
	(IMO No. 5979428)
Port of inspection:	Shanghai, China
Date of inspection:	21.01.2021
Detention:	Yes*

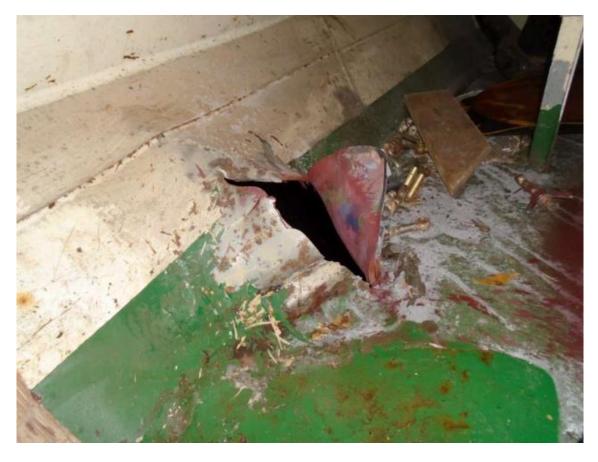
Hull damage impairing seaworthiness:
The hull of void space forward center and around bulbous bow broken with the hole approx. dimensions 4.5m horizontal and vertical 3.2m and the other spots damaged, which impairing seaworthiness.

Reason for winning the prize:
This photo shows the evidence of hull damage.

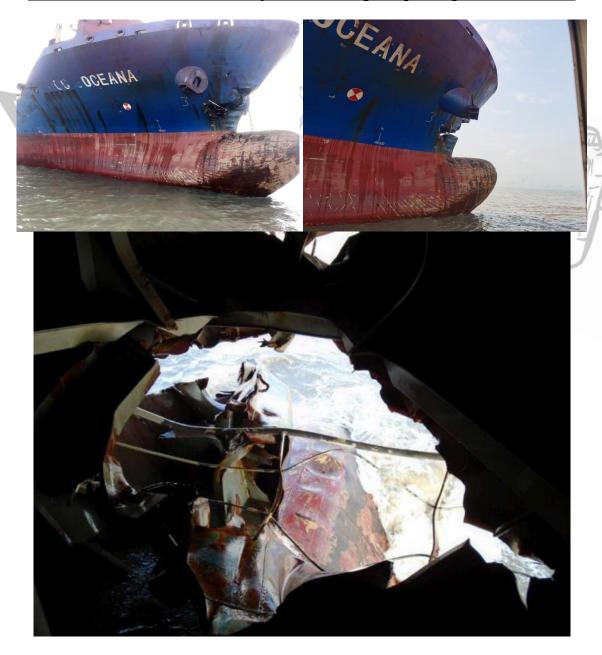
Pictures of the same deficiency: Hull damage impairing seaworthiness

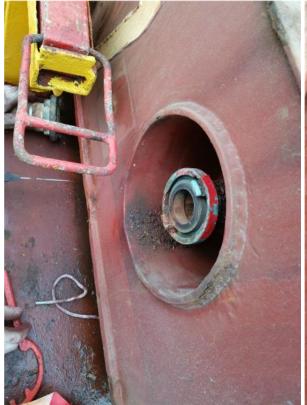
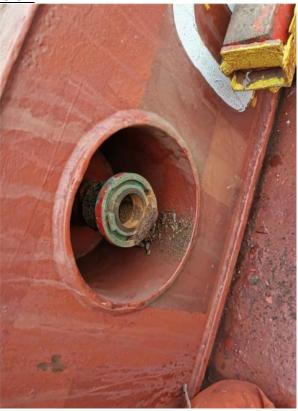
<u>Pictures of detainable deficiency: Both the fire hydrants of spray fire protect</u> <u>for No.2 cargo hold are unable to connect with the fire hose due to serious corrosion</u>

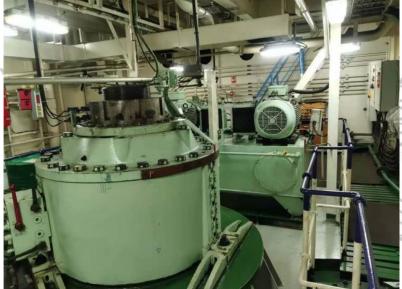
<u>Pictures of other deficiency: The steering gear was unable to operate from bridge due to failure</u>

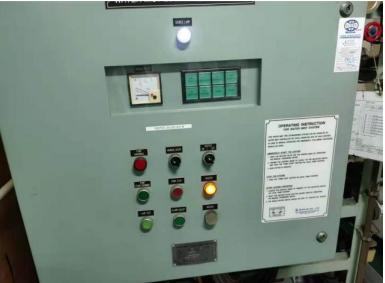
Pictures of other deficiency: Defective fixed fire extinguishing installation

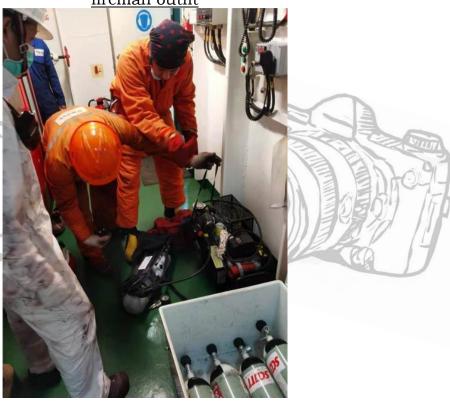
Picture of other deficiency: The designed crew not familiar with the wearing of fireman outfit

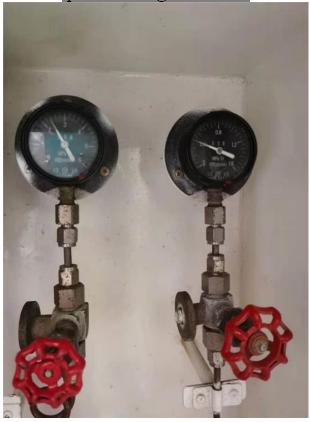
<u>Picture of other deficiency: The air pressure of the air cylinder for oil tank</u> <u>quick-closing valves low</u>

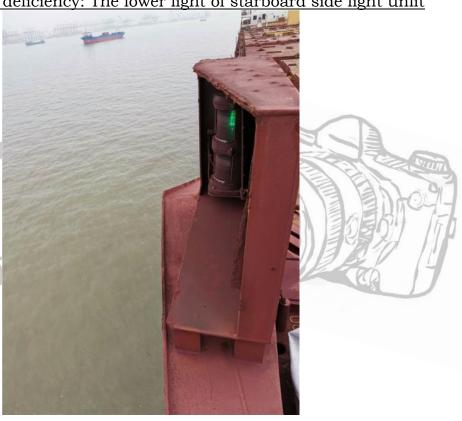
Picture of other deficiency: The lower light of starboard side light unlit

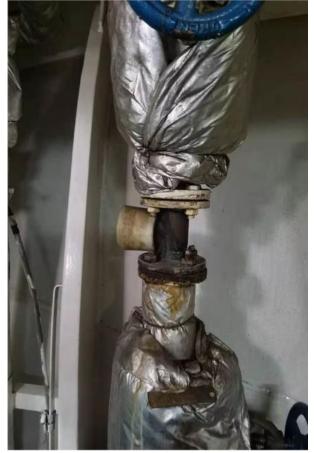
Picture of other deficiency: Pipe for boiler feed water system temporarily repaired with nylon block, and the heat insulation material missing

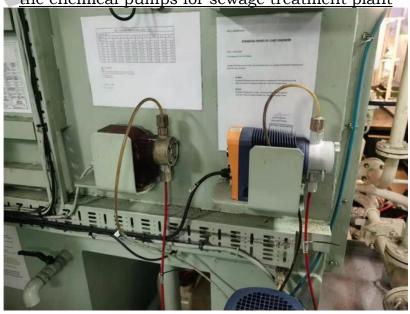
Picture of other deficiency: The key engineers not familiar with the testing of the chemical pumps for sewage treatment plant
