Deficiency Photo of the Year – 2009

Ship name:	YING SHUN
IMO Number:	7507291
Flag:	Panama
Call sign/MMSI	3ECS8/371453000
Ship type:	Bulk carrier
Date keel laid:	1977
Gross tonnage:	21,952
Recognized organization:	Isthmus Bureau of Shipping, S.A.
ISM Company:	EVER GAIN SHIPPING SA (IMO No.5339822)
Port of inspection:	Vanino, Russian Federation
Date of inspection:	22.10.2009
Detention:	Yes*

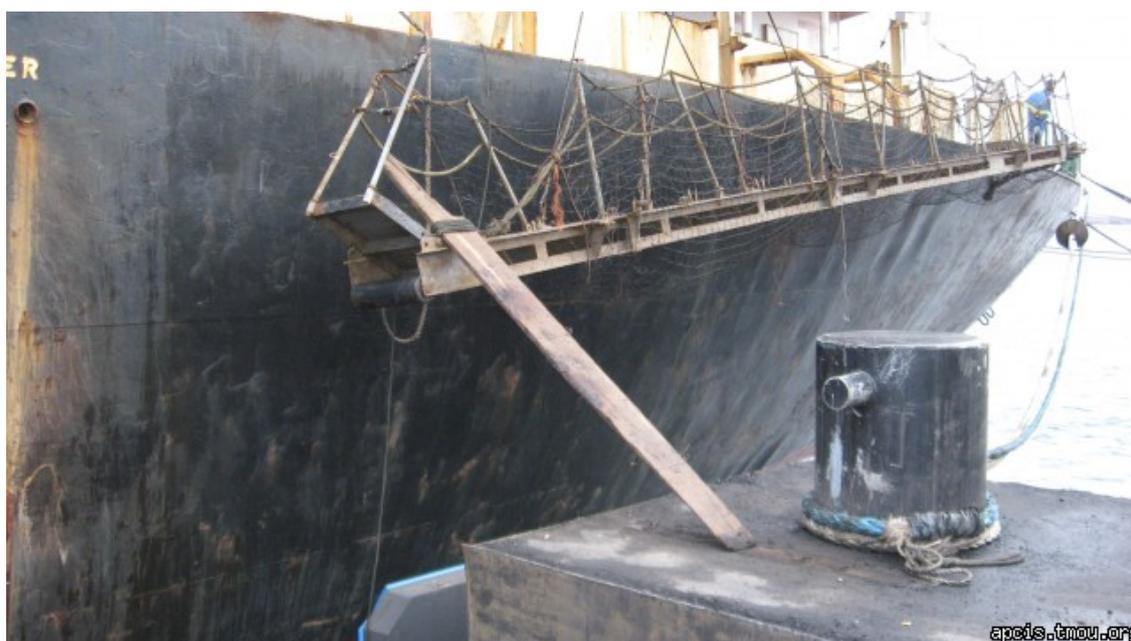
Nature of deficiency:	Working conditions: Accident prevention-Accommodation ladder in poor condition.
Reason for winning the prize:	This photo demonstrates the unsafe stowage of the gangway ladder which would endanger the safe access to the vessel.
Photo of detainable deficiency:	No

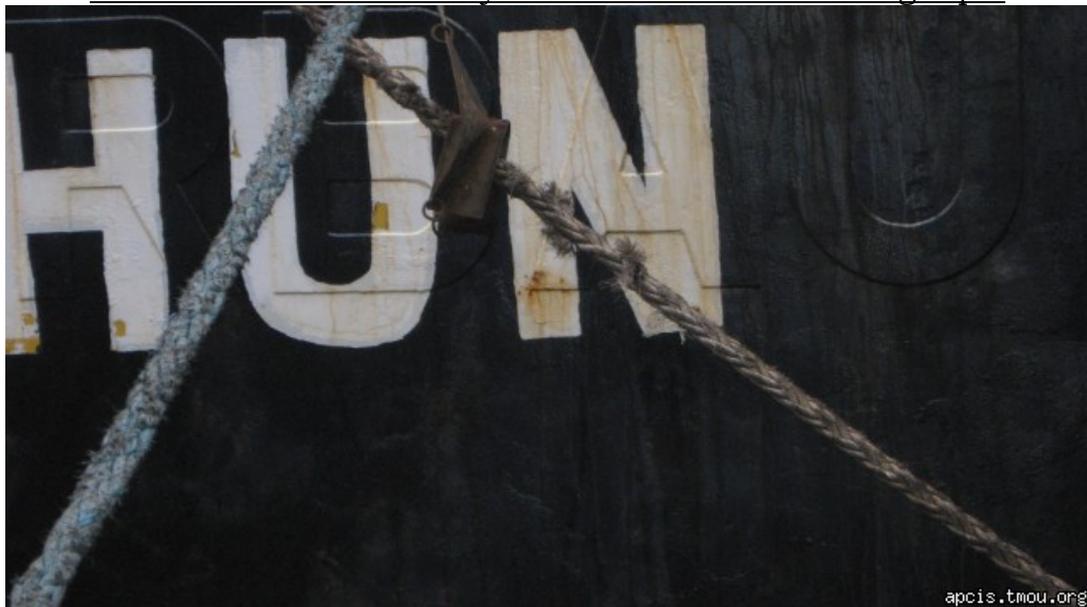
Picture of other deficiency: Bad condition of mooring rope.

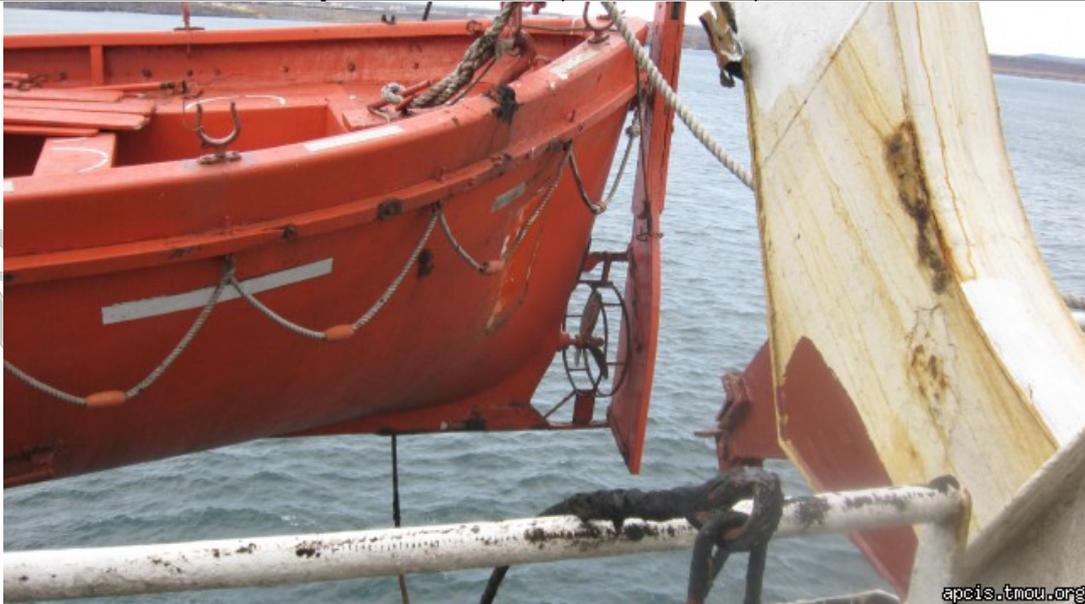
Picture of other deficiency: LIFEBOATS (P.S., STB.S.) - SCATES ARE MISSING

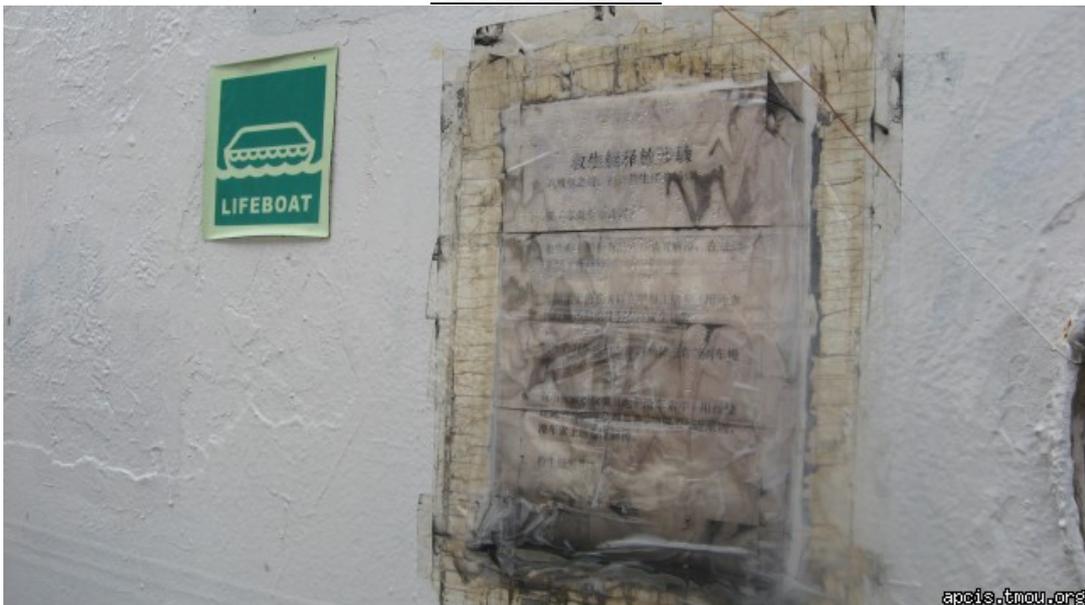
Picture of other deficiency: LAUNCHING INSTRUCTIONS FOR LIFEBOAT ARE UNREADABLE

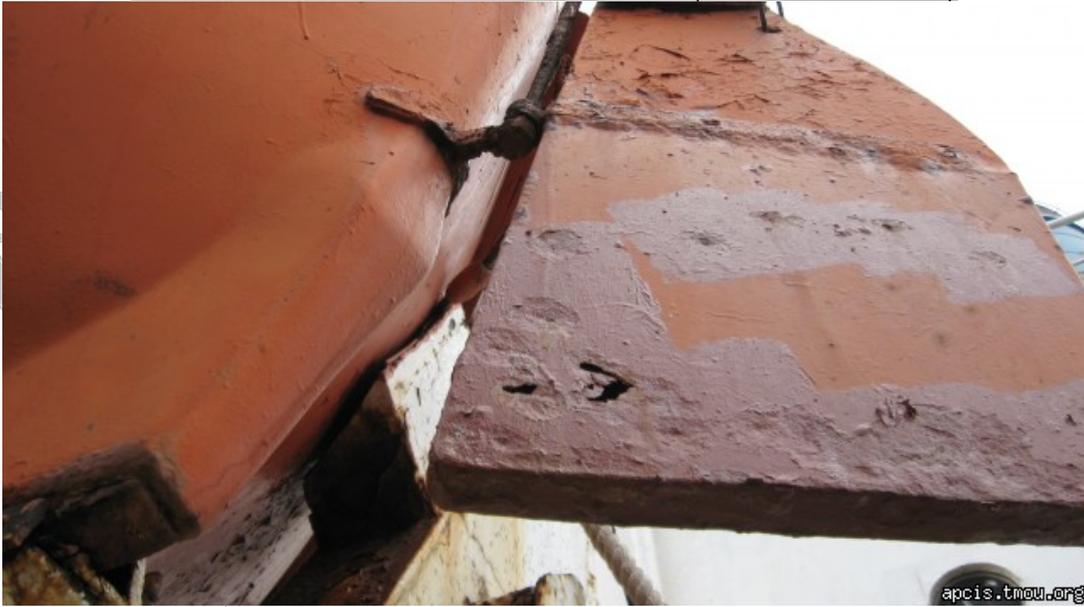
* Detention was warranted for reason of deficiencies of overdue bottom survey, corrosion of lifeboat rudder and corrosion of securing devices for lifeboat lashing.

Picture of other deficiency: LIFEBOAT (P.S.) - RUDDER IS CORRODED AND HAS HOLES DUE TO CORROSION (Detainable item)

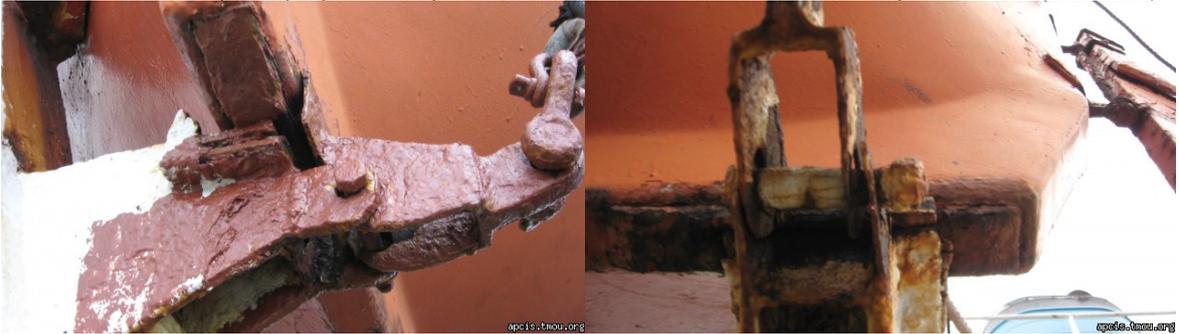
Pictures of other deficiency: SECURING DEVICES FOR LASHINGS OF LIFEBOATS (P.S.), (STB.S.) ARE HEAVILY CORRODED (Detainable item)

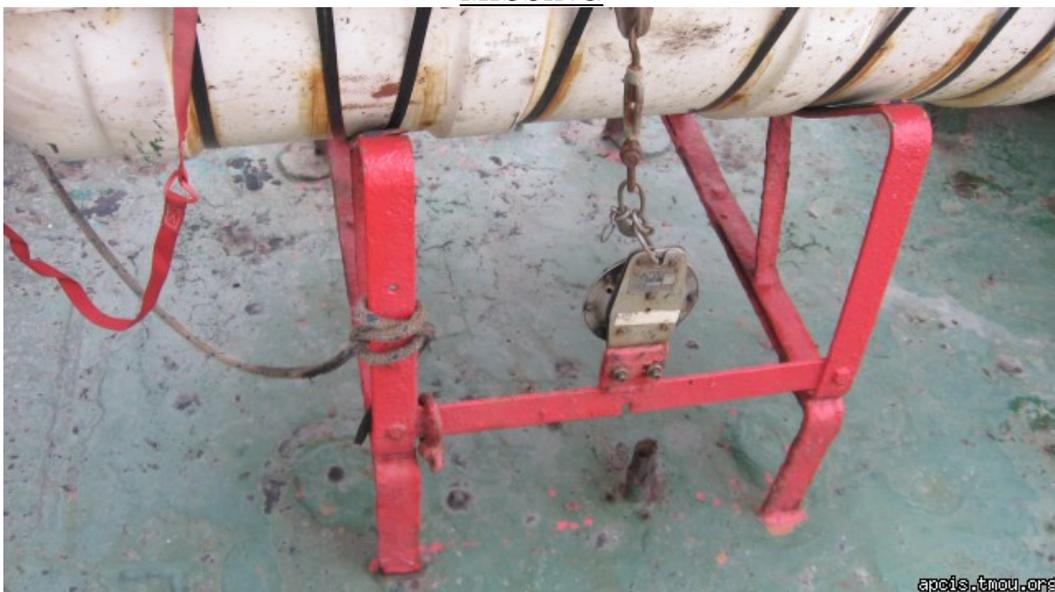
Picture of other deficiency: STOWAGE OF LIFERAFT (P.S.) - WEAK LINK IS MISSING

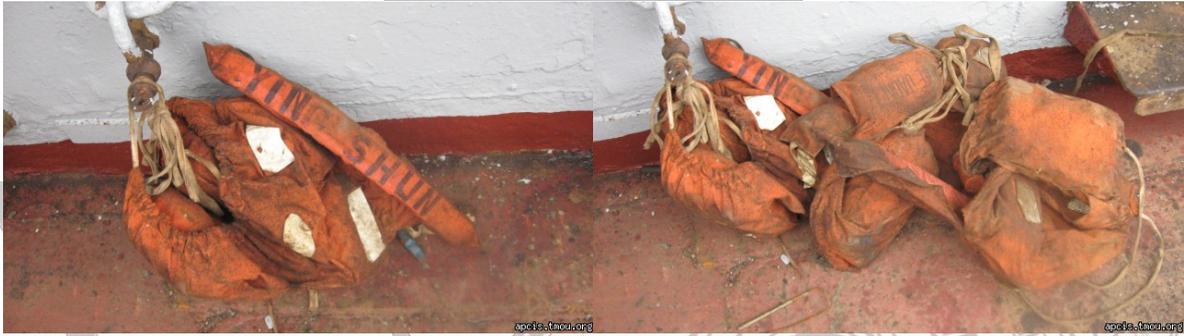
Pictures of other deficiency: LIFEJACKETS FOR LIFERAFT ON FORECASTLE ARE IN POOR CONDITION

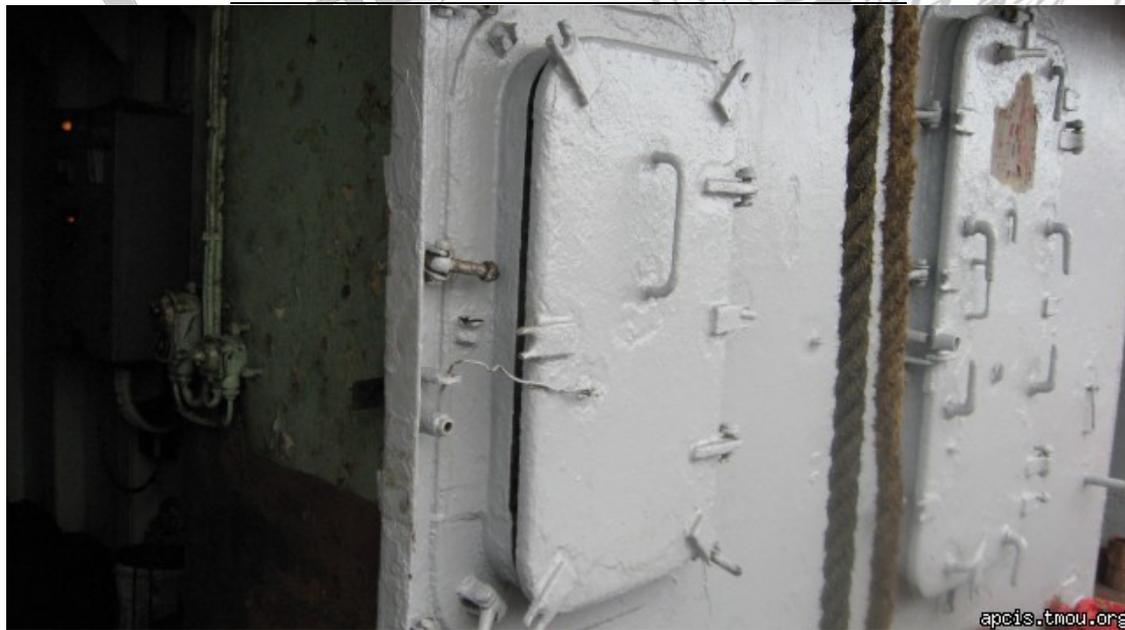
Picture of other deficiency: CLOSING DEVICES FOR THE DOOR OF CARGO HOLD VENTILATION ROOM ARE MISSING
