## Safety risks of lifting slings encased in plastic sheathing on freefall lifeboats

This update is issued to raise awareness of the potential risk of using lifting slings encased in plastic sheathing for freefall lifeboats.

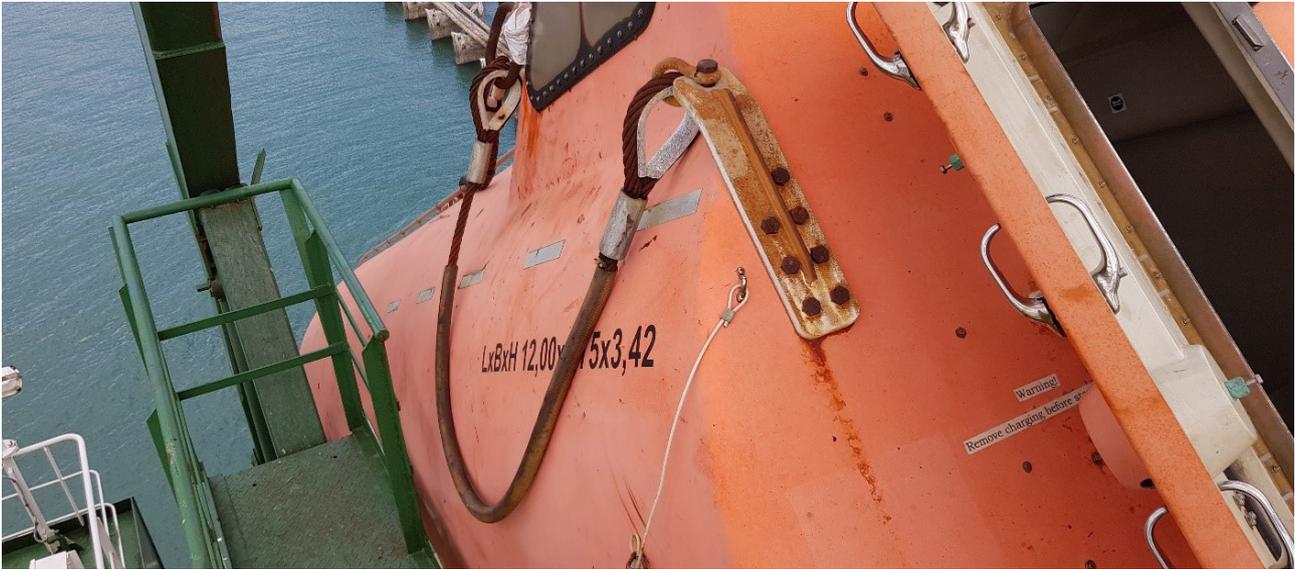
Figure 1. Lifting sling encased in plastic sheathing

Such arrangements have been found to restrict visual inspection of the wire ropes enclosed within and furthermore, prevent routine maintenance and survey being effectively carried out. As a result, the wire ropes may be seriously corroded due to passage of moisture/air inside and yet go undetected.

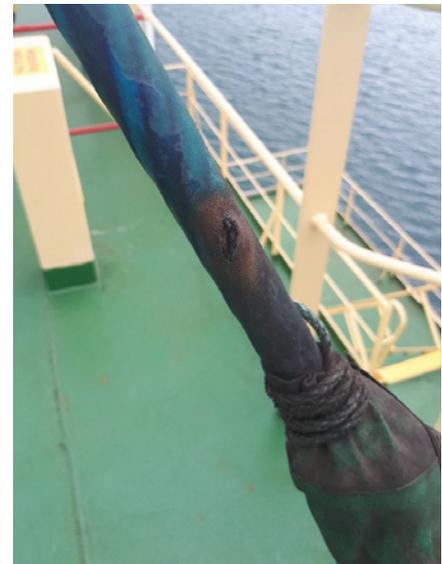
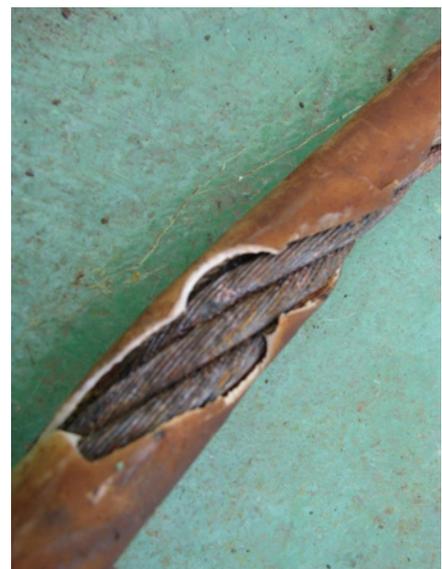
Investigations into the failure of the slings revealed that the slings parted under normal operational load due to significant weakening, as a result of internal corrosion. The internal corrosion within the sheathing went undetected, even though regular inspections were reportedly being carried out, as required by SOLAS Chapter III, Regulation 20 (Operational readiness, maintenance and inspections).

Figure 2. Corrosion beneath plastic sheathing.

1. Masters and senior officers should physically check if freefall lifeboat lifting slings are encased in plastic sheathing.
2. Masters, senior officers and surveyors should physically inspect the sling for signs of corrosion beneath the sheathing.
3. Companies should consider means to ensure the inspection of slings encased in plastic sheathing and the risks posed by them is appropriately captured by their safety management system.
4. Consideration should be given to the use of slings without a plastic sheath, or an alternative method of encasing the sheath which allows for removal for inspection. Operators may wish to contact the lifeboat manufacturer for guidance in this regard.
5. Companies should ensure that the slings are renewed on a regular basis, using the same principle of maintenance of lifeboat falls as stipulated in SOLAS Chapter III, Regulation 20.4.

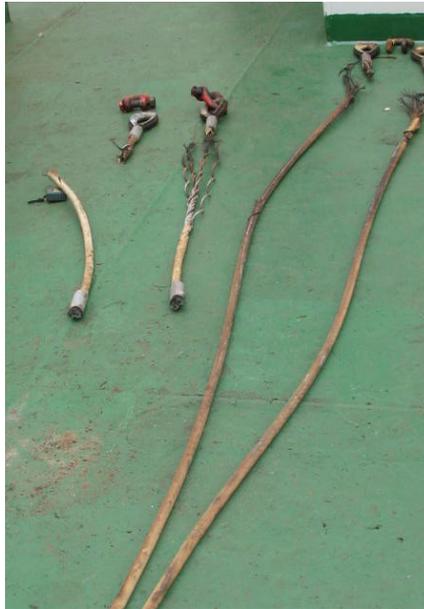
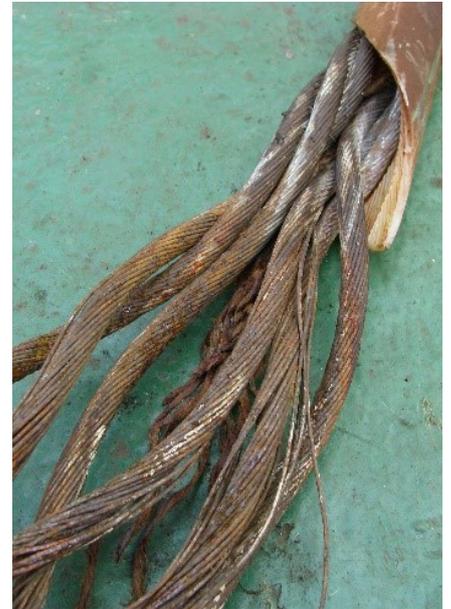
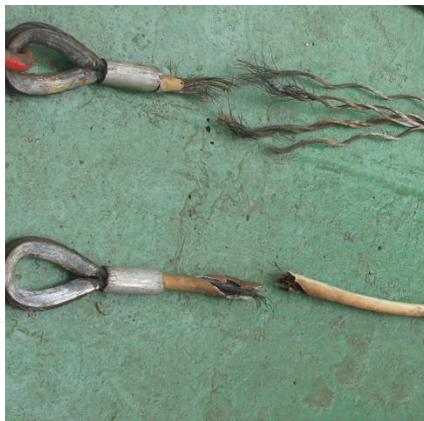
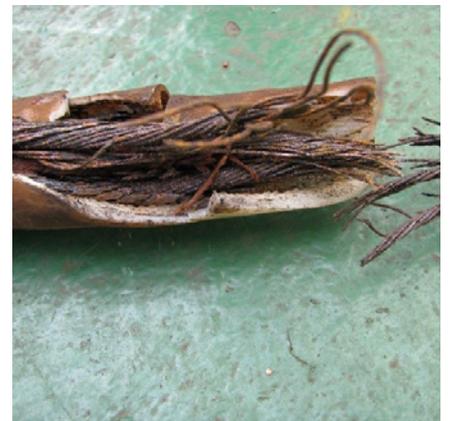
Serious incidents have occurred during launching and retrieval of freefall lifeboats using the secondary means of launching and retrieval with purpose built lifting slings encased in plastic sheathing. The slings have parted resulting in the freefall lifeboat plunging several meters into the sea with crew inside.

Figure 3. Lifting slings parted due to undetected corrosion.

Furthermore, while it is a requirement under SOLAS Chapter III, Regulation 20.4 that falls used for launching of lifeboats are renewed when necessary if found deteriorated, or at intervals of not more than 5 years – there is no requirement in SOLAS for renewal of the slings used in secondary means of launching of freefall lifeboats. As such, many owners of vessels do not consider renewing the slings, as the true condition of the encased wire ropes cannot be correctly determined.

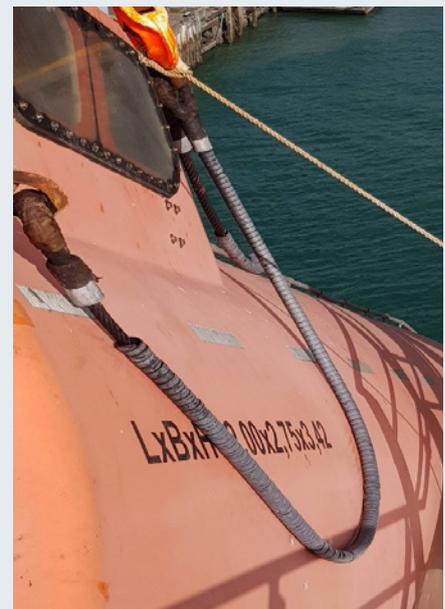
Figure 4. Alternative sheathing arrangement which allows for inspection
