Deficiency Photo of the Year – 2017

Ship name:	BINTANG LIBERTY
IMO Number:	8844361
Flag:	Indonesia
Call sign/MMSI	YDWM
Ship type:	General cargo/multipurpose ship
Date keel laid:	10.04.1990
Gross tonnage:	508
Recognized organization:	Biro Klasifikasi Indonesia
ISM Company:	PT Intan Pasific Indonesia Lines (IMO No. 5923991)
Port of inspection:	Singapore
Date of inspection:	28.11.2017
Detention:	Yes

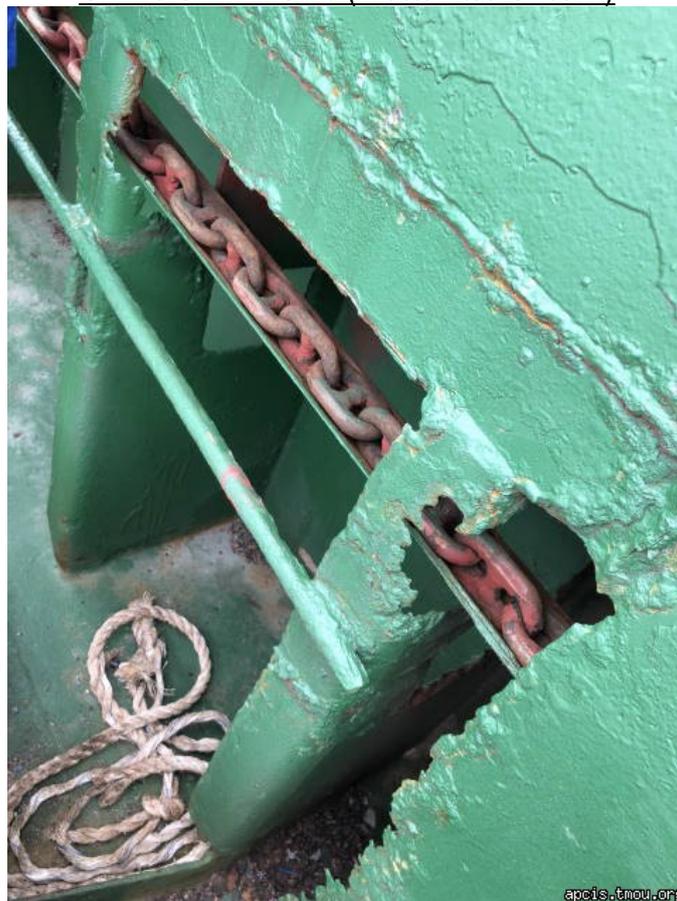
Picture of other deficiency: NUMEROUS TRANSVERSE FRAMES AND HATCH COAMING STAYS WERE WASTED SONF THINNED AT BOTH SIDES OF NO.1 CARGO HATCH. (Detainable item)
